Facility Review

A report on the condition of facilities at Missouri's public colleges and universities

December 2009

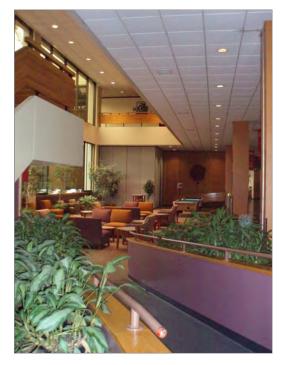
Inside the University Center.

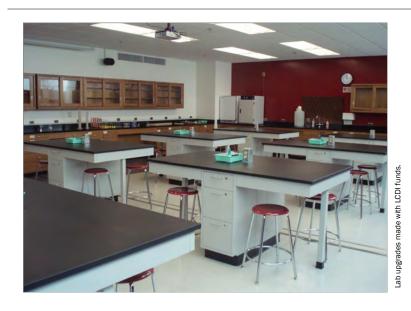
echnical lab on the Florissant Valley campus
